**ADDENDUM #1 LEAD SCREENING
(#2223-10 HVAC IMPROVEMENTS)**

**LEAD XRF PRE-RENOVATION SCREENING
CHESHIRE HIGH SCHOOL – 525 SOUTH MAIN STREET, CHESHIRE CT
HVAC IMPROVEMENT PROJECT
CS# 206-595, 11/8/2022, PAGE 1 OF 6**

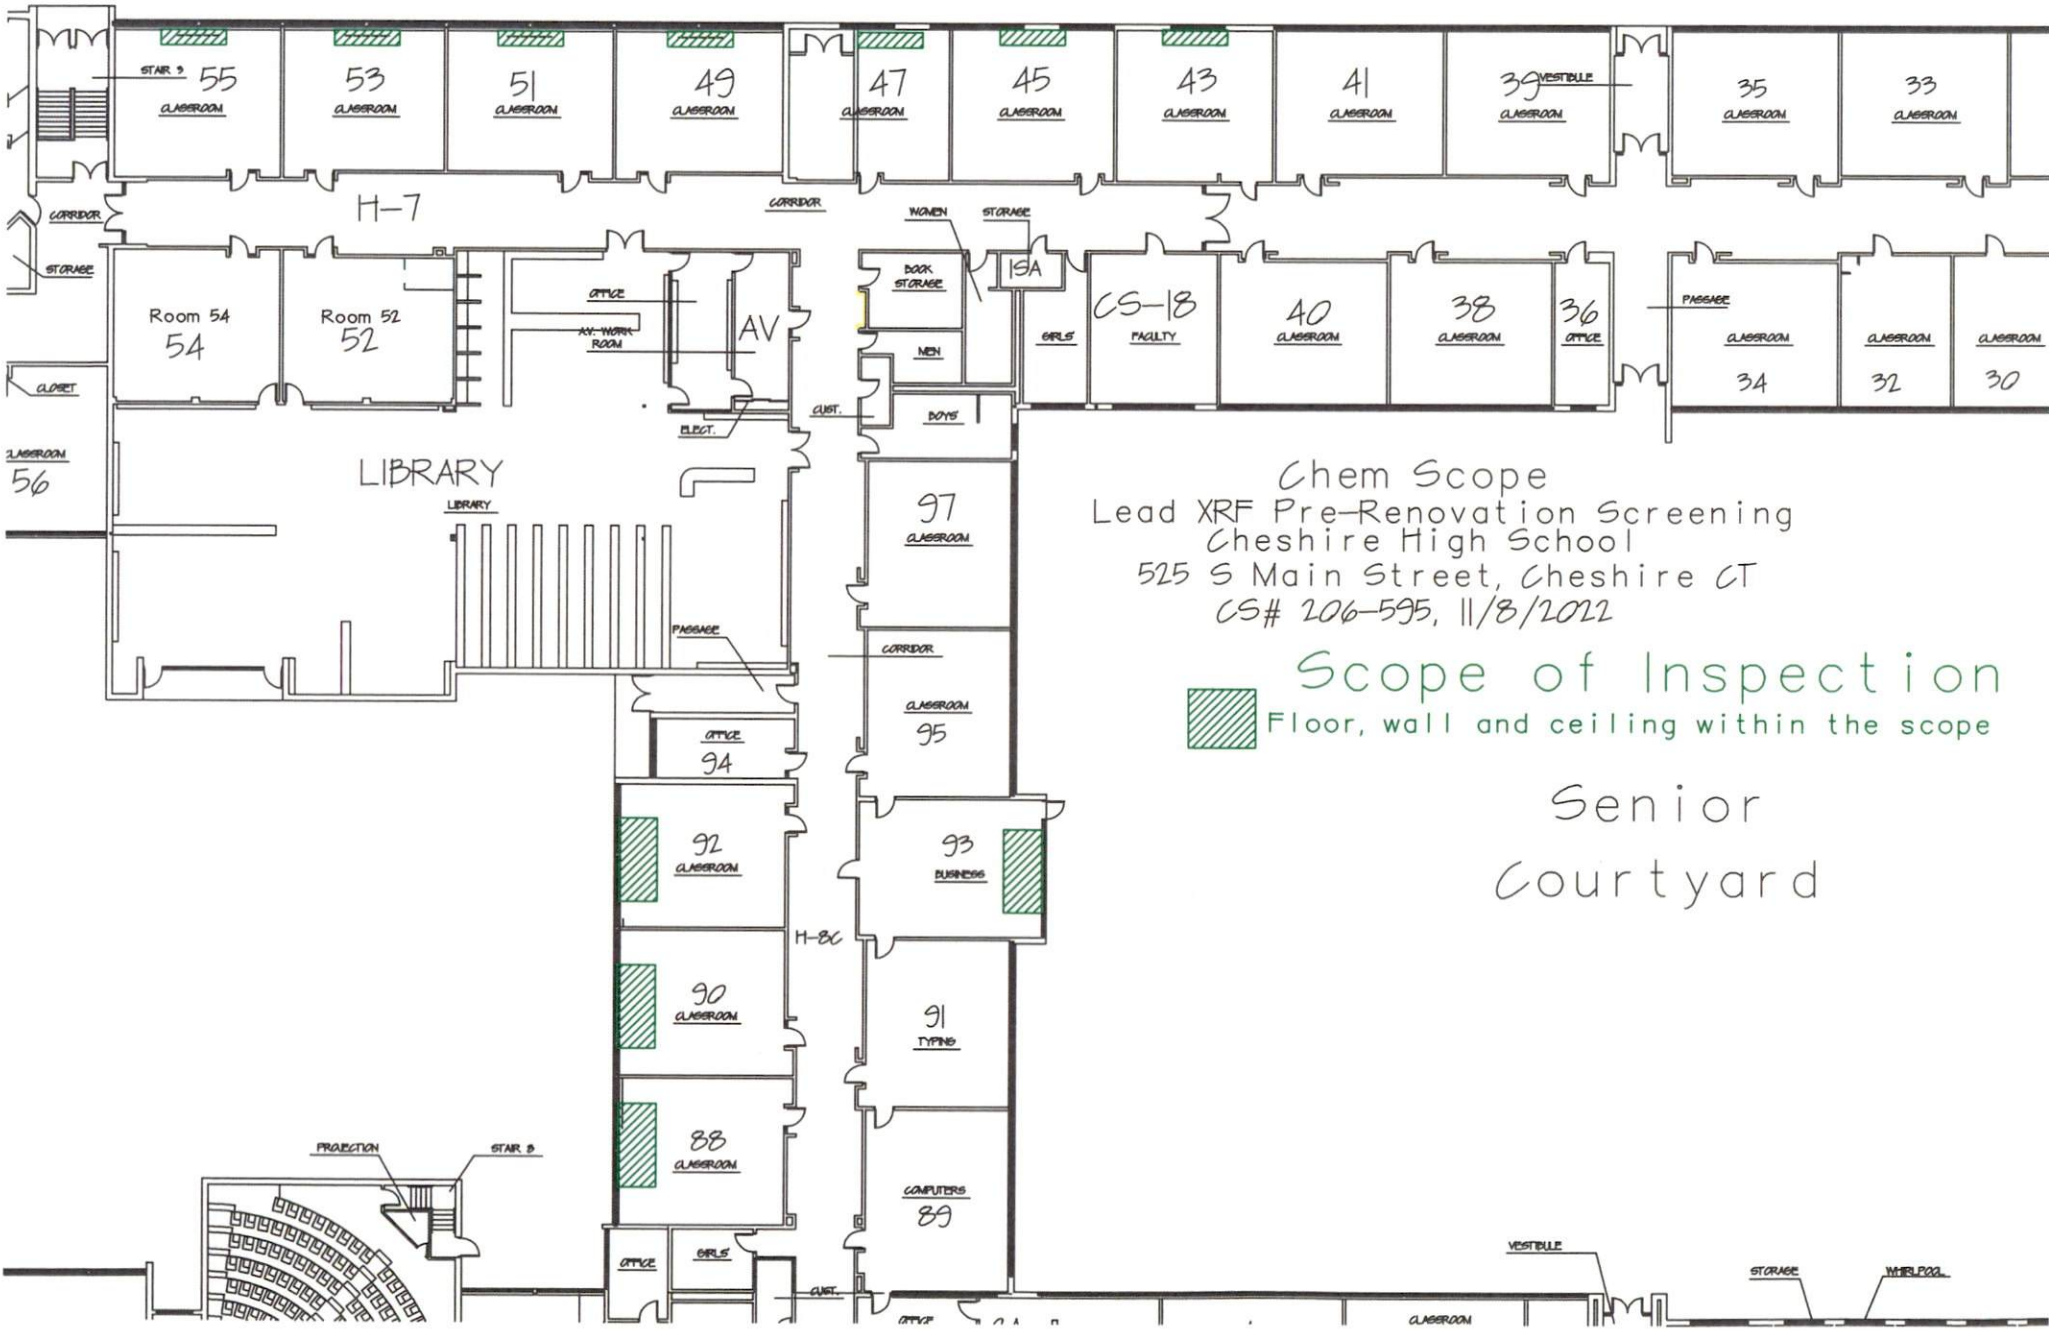
Chem Scope
 Lead XRF Pre-Renovation Screening
 Cheshire High School
 525 S Main Street, Cheshire CT
 CS# 206-595, 11/8/2022

Scope of Inspection
 Floor, wall and ceiling within the scope
